U.S. Department
of Transportation
Federal Aviation
Administration

ADVISORY CIRCULAR 43-16A

AVIATION MAINTENANCE ALERTS

ALERT
NUMBER
272

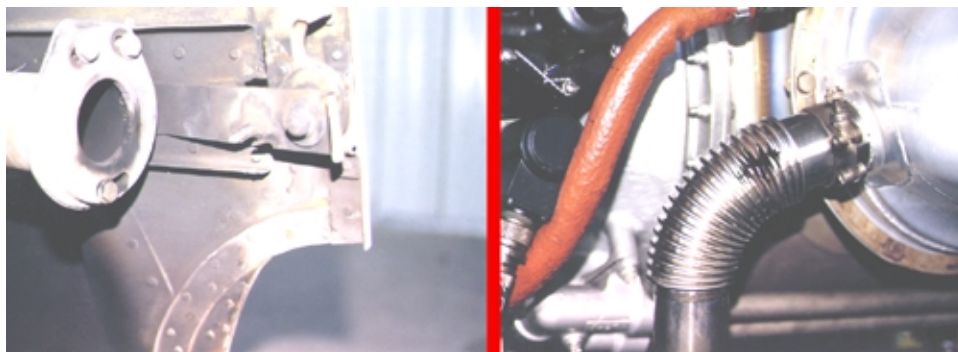
Problems have arisen involving the angle of protrusion on the welded exhaust stack port. If the angle of the stack is not oriented slightly inboard (approximately 5 to 7 degrees), the attaching duct can chafe and wear on the adjacent cowling latches. The chafing action may penetrate the metal duct and damage the cowling latches. (Refer to the illustration.) Penetration of the duct will release extremely hot engine exhaust gases

inside the cowling and create a very serious hazard to flight safety.

It appears there is no standard angle for the ducts welded to the exhaust stack. Consequently, the duct angle is different, to varying degrees, with each unit.

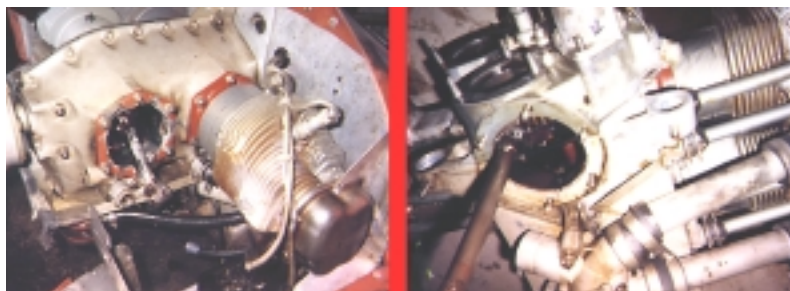
CESSNA**Cessna; Model 150L; Engine Damage; ATA 7310**

The pilot reported that during a flight, the engine began running rough, got progressively worse, made a loud noise, and failed. He landed the aircraft safely and summoned maintenance personnel. (Refer to the illustration.)

The technician discovered the number 2 cylinder, piston, rod, and wrist pin failed with varying degrees of damage. The cylinder separated from the engine case, the piston was severely heat damaged, the connecting rod was bent, and the wrist pin was galled and heat damaged. He also

found the number 2 cylinder intake boot was dislodged and caused the cylinder fuel/air mixture to become extremely lean and resulted in the damage found. He believes the intake boot became dislodged due to improper positioning of the "worm gear" hose clamp.

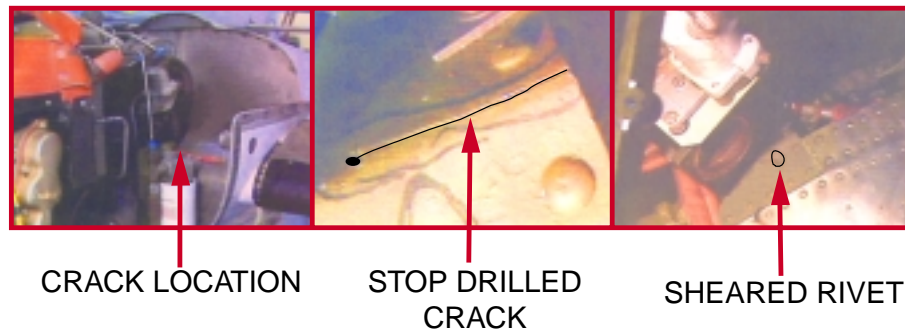
Cessna; Model 421C; Golden Eagle; Nacelle Structural Defect; ATA 5410

While conducting an annual inspection, the technician discovered a crack in the left engine nacelle beam.

The crack was approximately 1.5-inches long and was located on the upper beam cap. (Refer to the illustration.) The crack had been previously "stop drilled," which is not an approved repair. This type of damage requires replacement of the beam assembly. Also, the technician found a sheared rivet in the same area.

The submitter suspects the crack was caused by improper fit during manufacture which imposed abnormal stress. The proximity to the turbocharger waste gate and possible exhaust system leakage may have contributed to the defect.

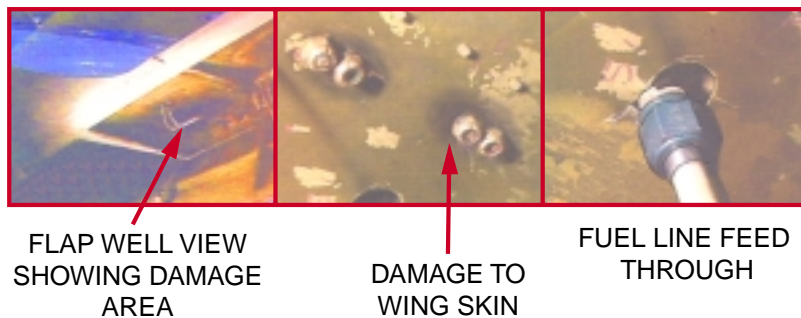
Cessna; Model 421C; Golden Eagle; Fuel Tank Security Damage; ATA 2810

During a scheduled inspection, the technician discovered the right nacelle baggage locker fuel tank security was damaged. The 28-gallon nacelle fuel tanks were installed in accordance with Supplemental Type Certificate (STC) SA2872SW.

The fuel tank hold-down fasteners were pulling through the upper wing skin. (Refer to the illustration.) The technician suspected the entire fuel tank installation did not meet industry standards. The technical data associated with the STC was not available in the aircraft records, and he declined to approve the aircraft for return to service. At the time of this report, he was awaiting delivery of the necessary technical data before conducting a conformity inspection.

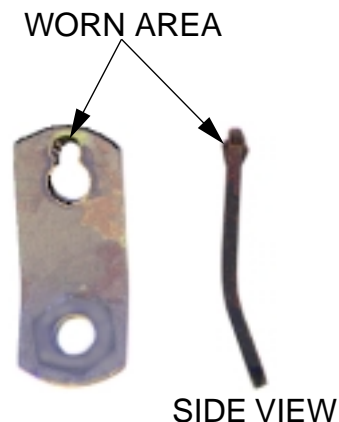
While complying with the requirements of Airworthiness Directive (AD) 98-08-18, the technician discovered an associated defect.

AD 98-08-18 and Piper Service Bulletin 626C deal with inspection and replacement criteria for the elevator down bungee spring and one link. The AD states it may be necessary to replace the existing spring link (P/N 42376-02) with a new link (P/N 71086-03) when the spring is replaced. However, the spring configuration requires a link at each end for attachment. The submitter found the other link (P/N 56981-02) severely worn in an elongated shape at the spring attachment hole. (Refer to the illustration.)

The submitter suggested amending AD 98-08-18 to include replacement of both spring attachment links.

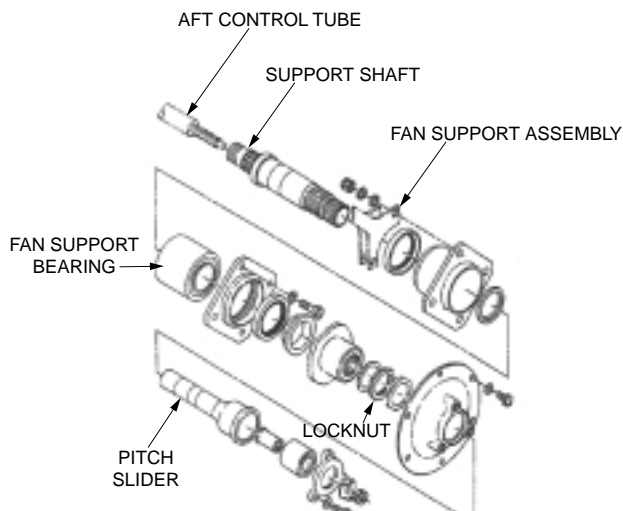
While removing the No Tail Rotor (NOTAR) fan bearing, the technician discovered pitting corrosion on the fan pitch slider (P/N 500N5367-3) and the fan support shaft (P/N 500N5357-11). (Refer to the illustration.)

When the technician replaced the bearing, fan pitch slider, and the fan support shaft, he noticed excessive binding on the assembly. He consulted an onsite manufacturer's technical representative and was told the required torque of 60 to 70 foot-pounds applied to the pitch support shaft locknut (P/N NAS1493-6F) was excessive and was the major cause for the binding. It was obvious to the onsite representative that 60 to 70 foot-pounds of torque caused the support shaft to stretch, thereby reducing the inside diameter and creating the binding condition. By reducing the applied torque by 5 pounds at a time, they were able to determine

the ideal torque application was approximately 45 to 55 foot-pounds. This torque range, although effective in greatly reducing the binding condition of the slider, is not an approved procedure.

The manufacturer is aware of this situation, and a change of the technical data may be forthcoming. Any questions concerning this subject should be addressed to the manufacturer.

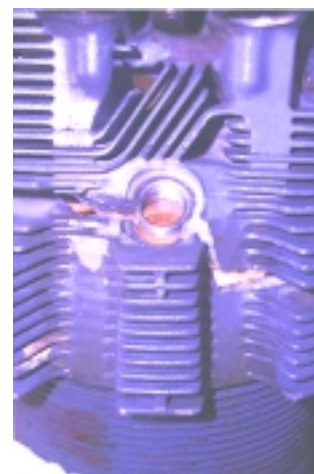
At the time of this report, the submitter had not determined a cause for the cracked cylinders.
